Manhole Inspection Summary

Manhole # S39A2_002MH

Insp Date: **12/26/07 8:47 AM**

Location Address: **3818 6th St**

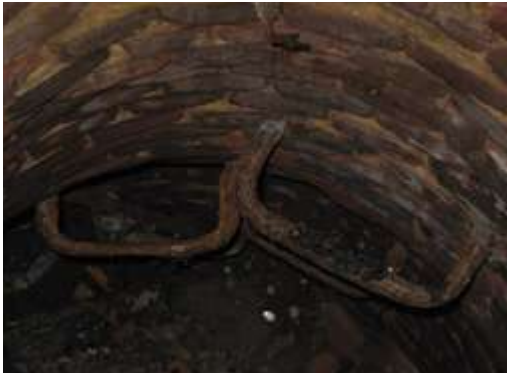
Count: **4** Missing: **1** ☒ **Corroded**

steps

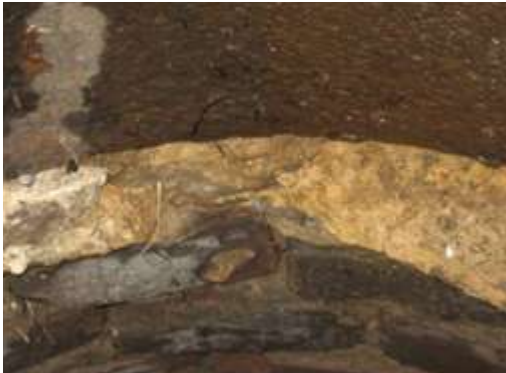
Defect 1

Condition: ☐ Sound ☐ Cracked ☐ Root Intrusion ☒ **Loose Brick** ☐ Deteriorated

loose brick & mortar

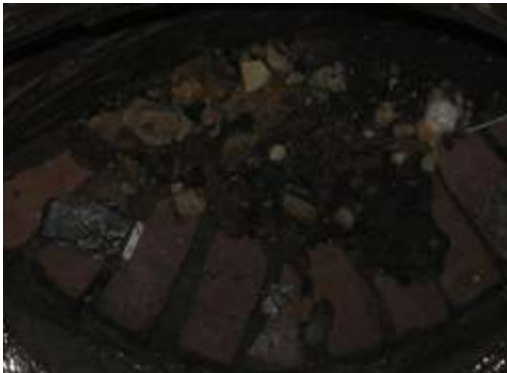
Defect 2

debris

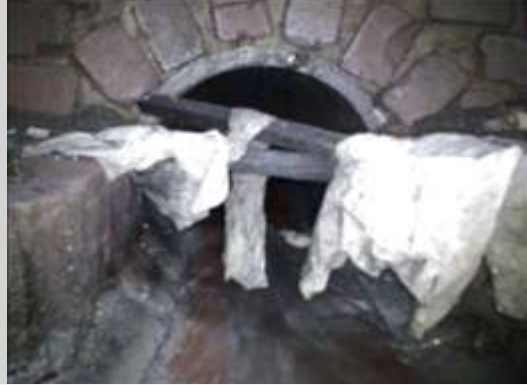
12 O'Clock Outflow

10 in. Circular Gravity Sewer
Pipe Out @ 12 O'Clock

Pipe Height: **12** (in.) Rod and Bar (Angled)
Pipe Material: **Clay** ☐ Pipe Lined
Invert Depth: **9.91** (ft.) Flow Characteristics: **Fast**
Deposits: ☒ None ☐ Mud ☐ Sludge ☐ Debris ☐ Grease
Silt Depth: (in.) Deposits Extent:
Infiltration: **None** Pipe Seal Cond: **Sound**

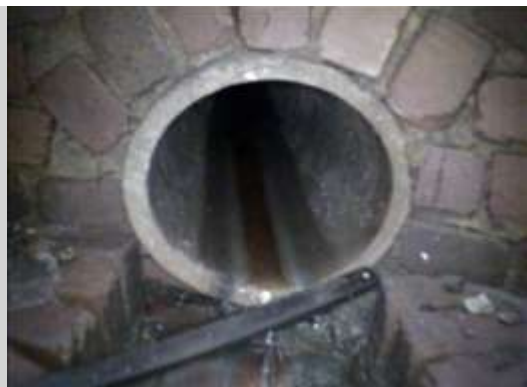
3 O'Clock Inflow

8 in. Circular Gravity Sewer
Pipe In @ 3 O'Clock

Pipe Height: **9.6** (in.) Rod and Bar (Angled)
Pipe Material: **Clay** ☐ Pipe Lined
Invert Depth: **9.26** (ft.) Flow Characteristics: **Fast**
Deposits: ☒ None ☐ Mud ☐ Sludge ☐ Debris ☐ Grease
Silt Depth: (in.) Deposits Extent:
Infiltration: **None** Pipe Seal Cond: **Sound**

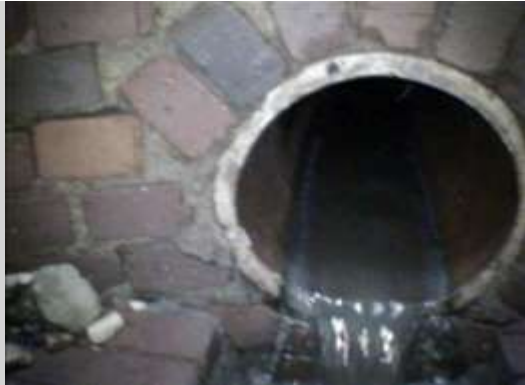
6 O'Clock Inflow

10 in. Circular Service Sewer

Pipe Height: **12** (in.) Rod and Bar (Angled)

Infiltration: **None** Pipe Seal Cond: **Sound**

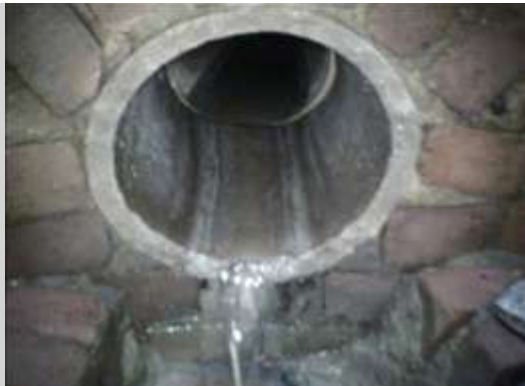
9 O'Clock Inflow

8 in. Circular Gravity Sewer

Pipe Height: **8.4** (in.) Rod and Bar (Angled)

Infiltration: **None** Pipe Seal Cond: **Sound**
